Innovative Automotive Solutions

June 2011, News Bulletin

Innovative AC Repair Solutions From S.U.R.&R.

Save "Time & Money" Repairing the Three Most Common AC Problems

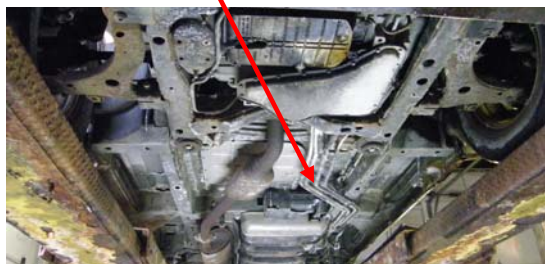
3. Rear air conditioning line/system is damaged and AC system cannot hold a charge

PROBLEM - Damaged Rear A/C line or component

S.U.R. & R. Solution: Simply block off the rear AC line using S.U.R.& R. Compression Union and Block Off. The repair can be done in minutes with a simple three step process:

1. Cut line
2. Install compression union & block off
3. Wrench tight - done!
